# Prognostics for Structures

Prasun Bansal, Abhinav Saxena, Edward Balaban, Kai Goebel  
Prognostics Center of Excellence, NASA ARC

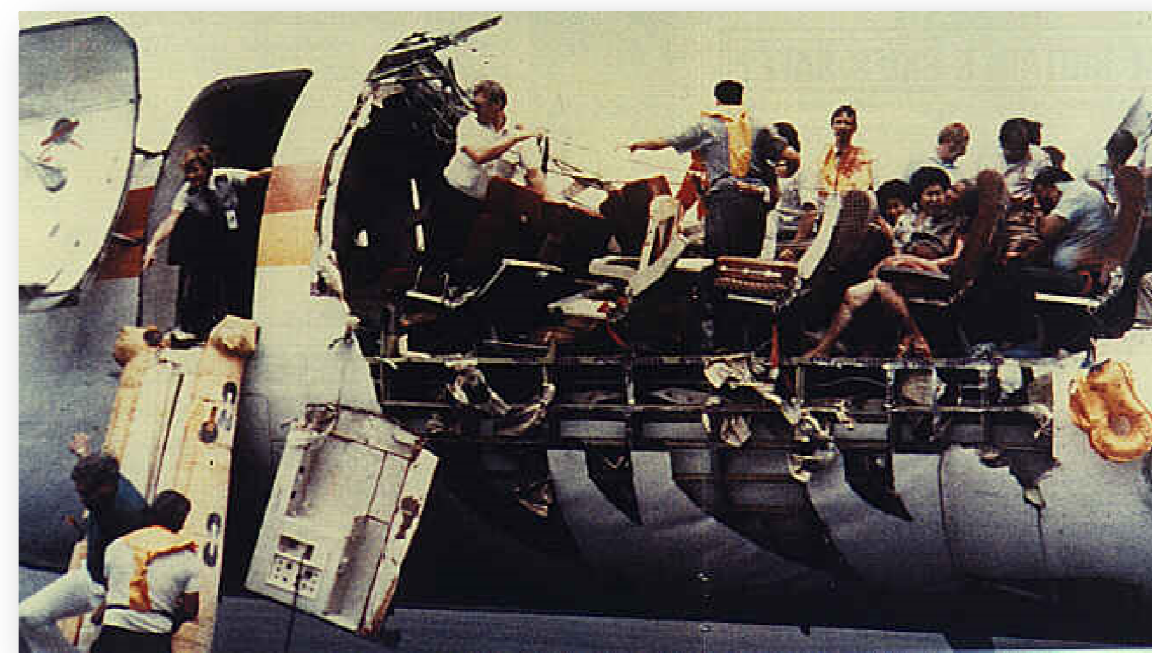
#### Aloha Airlines B-737 flight 243

- The fuselage ripped apart during flight, just after takeoff
- Failure was caused by metal fatigue exacerbated by crevice corrosion

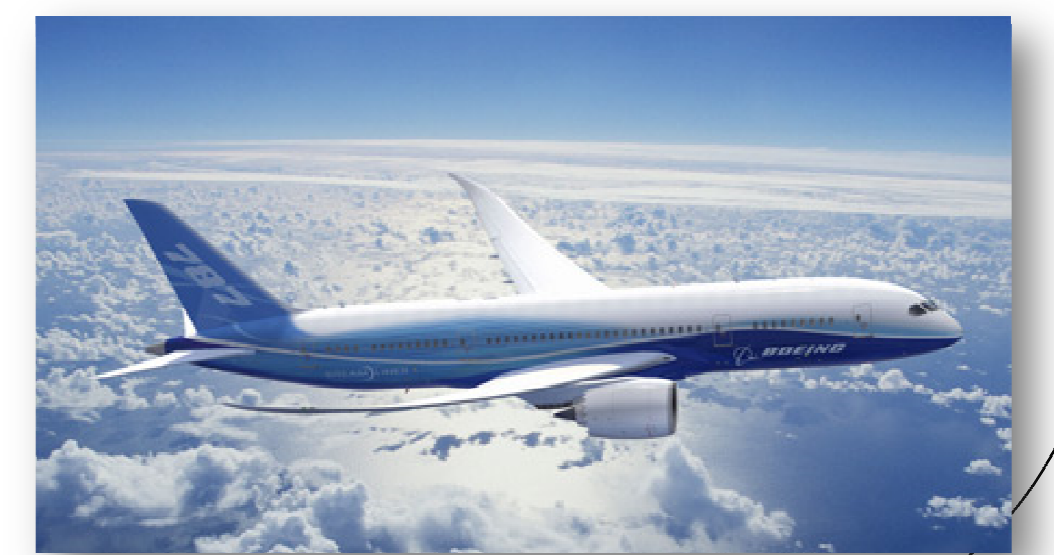
#### Boeing 787 Dreamliner

- It has an all composite body (fuselage, wings and control surfaces)
- A hammer drop during construction or maintenance on the composite body, could result in internal cracking and delamination, while leaving no signs of visible damage at the impact site
